Sonic and Impact Test for Structural Assessment of Historical Masonry

Alessandro Grazzini

Featured Application: Non-destructive diagnostic techniques for historical masonry buildings by the correlation of sonic and impact tests.

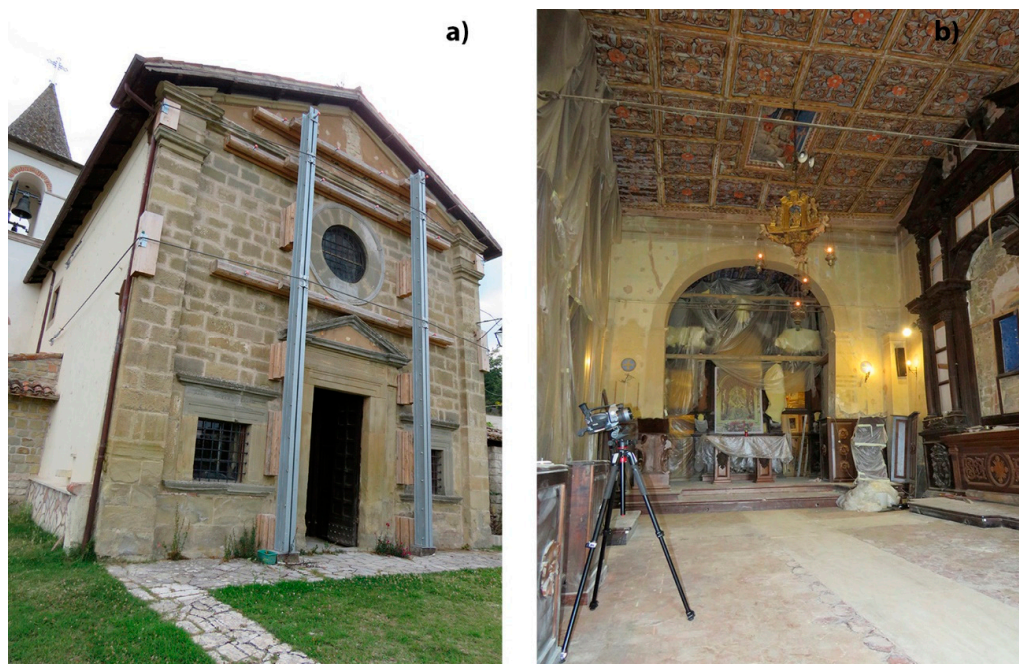
Figure 1. (a) Shoring works on the facade of the Sanctuary of Santa Maria delle Grazie at Varoni after 2016 Central Italy earthquake; (b) Interior of the single nave of the church.

The Sanctuary of Santa Maria delle Grazie is a church from the 15th century built by unordered masonry stone. The church suffered limited damage after the big seismic shock of 24 August 2016, concentrated, above all, in a slight principle of out of plane mechanism of the façade and some failures in the masonry structures (Figure 1). During the long seismic swarm of the 2016 Amatrice earthquake, the Government Department responsible for monuments carried out some punctual safety works. They consisted in a preliminary execution of lime mortar injections inside the stone walls in order to offer greater strength to the contrast of the new tie rods inserted in the façade plane, in the arch triumphal interior and contrast to the shoring of the facade (Figure 2).

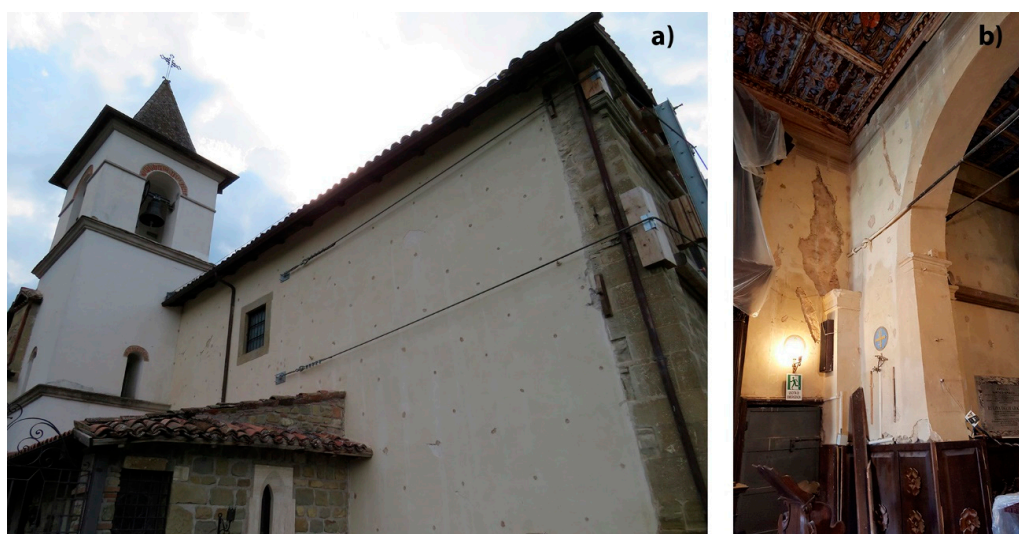
Figure 2. (a) Signs of the execution of mortar injections on the walls of the church; (b) Second iron tie carried out in pairs with the one existing at the triumphal arch.

The mortar injections were carried out for a limited depth inside the masonry wall, since there were uncertainties about the possible presence of a multi-layer stone masonry empty between the wall layers.

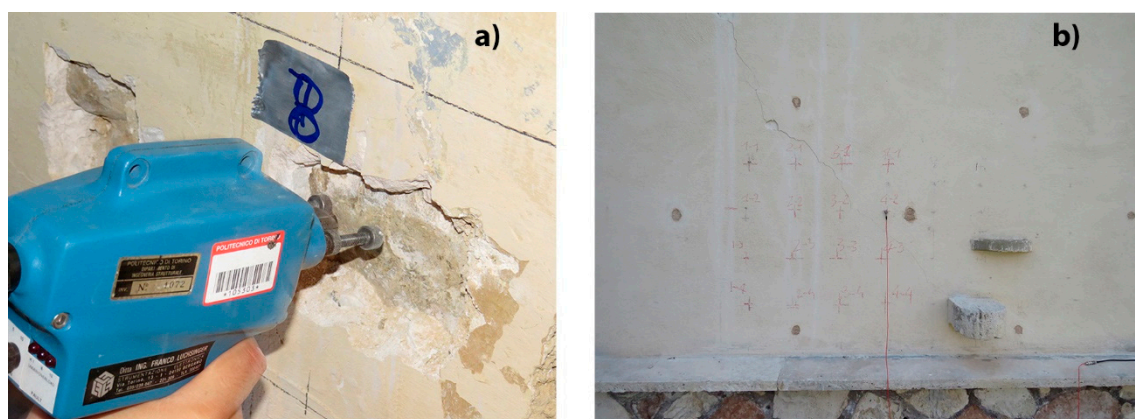
Figure 3. (a) Electric instrumented hammer during the sonic test; (b) Monoaxial accelerometer applied in the other surface of the analysed masonry wall.

The electric impact hammer used was PCB Piezotronics; model 086B09; variable force from 44.48 N to 4448.26 N; force sensor PCB model 208M51; 2.47 mV/N load sensor sensitivity. An accelerometer was used to receive the impulsive signal (Figure 3). The Dytran monoaxial accelerometer used in conjunction with an amplifier had the following technical characteristics: Dytran model 4102 C; model 3055B4; sensitivity 51.6 mV/g; measuring range: ± 100 g; frequency response: $1 \div 10,000$ Hz; mass: 10 g. Finally, a signal analyzer recorded both the applied load pulse and the sonic wave signal.

A wall surface of 1 m × 1 m was subdivided into a grid of equidistant points 20 cm, by removing the plaster around the points of application of the impact hammer (Figures 3b and 4a). Each single point of this grid consisted of a punctual sonic survey in order to obtain an average value of sonic velocity inside the analysed area of an highly inhomogeneous materials such as the masonry. At least three measurements were performed for each point, the average of which is shown in Table 1. The type of sonic survey was trasversal to the thickness (85 cm) of the masonry wall. Unfortunately, there were no surveys of the sonic wave before the mortar injections technique. Table 1 shows the sonic results of some significant points of the mesh, as the average of those of the entire test grid.

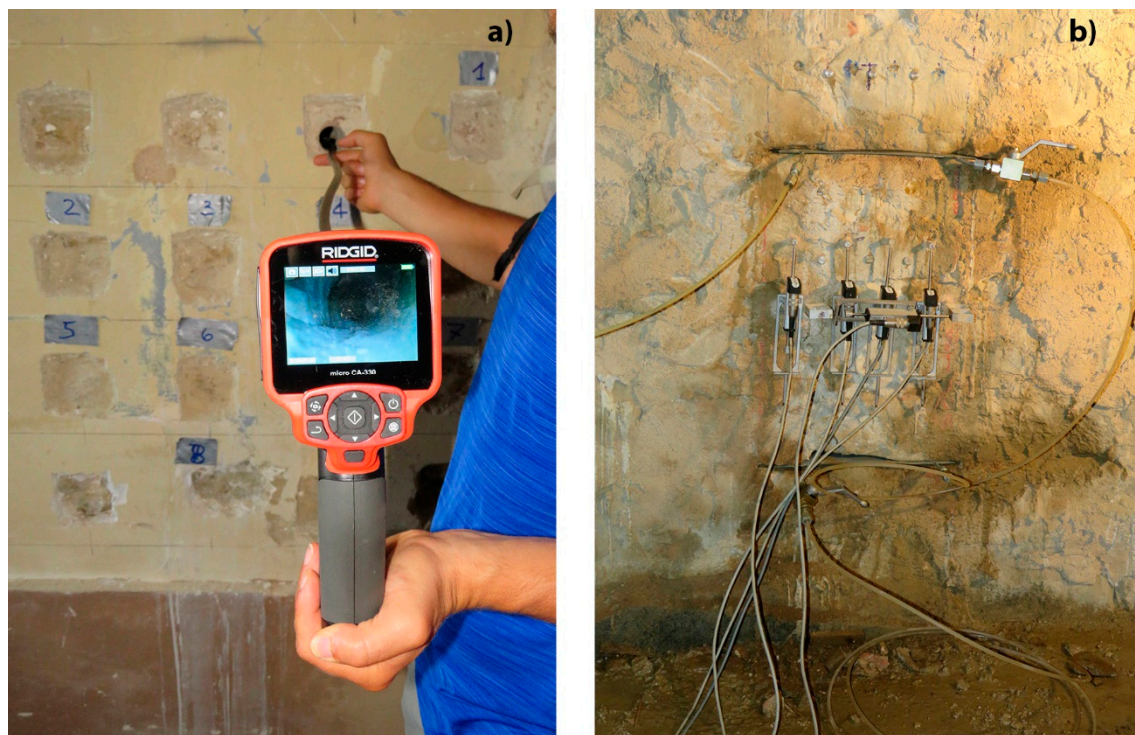
Figure 4. (a) Endoscopy test performed in the same area of the sonic test; (b) Double flat jacks test.

Endoscopy was performed with a RIDGID micro-CA 330 endoscope model (Figure 4a). The semi-destructive test to assess the main mechanical characteristics of the masonry was carried out using 4 mm thick and 77,765 mm² area flat jacks [9] (Figure 4b) through a hydraulic pump equipped by a DMM2 digital pressure gauge (linearity and 0.05% hysteresis) with a flow rate of 100 bar. The measurement of length variations was performed continuously by potentiometric displacement transducers (manufacturer: Novotechnik; model: TR50; stroke: 50 mm; deviation from linearity: 0.2%). The pressure and displacement values were acquired continuously using the HBM Spider8 acquisition device with a sampling frequency of 5 Hz. A hydraulic saw with a diamond disc was used to make the cut in which the jacks are to be positioned. Usually the pressure of the liquid in the jack was greater than the effort that the jack exerted on the masonry. In fact, the flat jack, because of its stiffness, was opposed to expansion when it was inflated, so the jack must be calibrated to obtain a conversion factor (km) that correlated the internal pressure of the fluid with the force applied to the masonry. The jack was calibrated in the laboratory through a compression test machine with a capacity of at least 450 kN. Through the loading-unloading cycles, entering the liquid under pressure inside the jack bound to the test machine plates, it was possible to obtain the conversion factor (km) as the angular coefficient of the straight line in the pressure-load diagram. The calibration, performed at the laboratory of the Politecnico di Torino according to the technical code ASTM C1197-04 [8], provided a value of km equal to 0.842. Moreover, the cutting area coefficient (ka) was given by the ratio between the area of the flat jack (77,765 mm²) and that of the cut performed (84,200 mm²) and was equal to 0.923. To obtain the value of compression stress acting on the masonry, it was necessary to multiply the pressure value detected by the liquid introduced inside the jack for the two correction coefficients (km) and (ka).

texture consisting of much larger stones (Figure 7) than that of the longitudinal walls of the church (Figure 4) on which the test was performed with flat jacks, endoscopy and sonic technique. This different texture, which was already uniform and without discontinuity, was present only along the piers of the main arch of the apse to ensure a greater strength against the thrusts of the arch. Therefore, this wall texture probably had superior mechanical characteristics than those detected on the longitudinal walls of the church. Therefore, it was not possible to make comparisons with the results obtained from the tests on the longitudinal walls, which revealed a more disarticulated texture, with stones that were smaller and irregular.

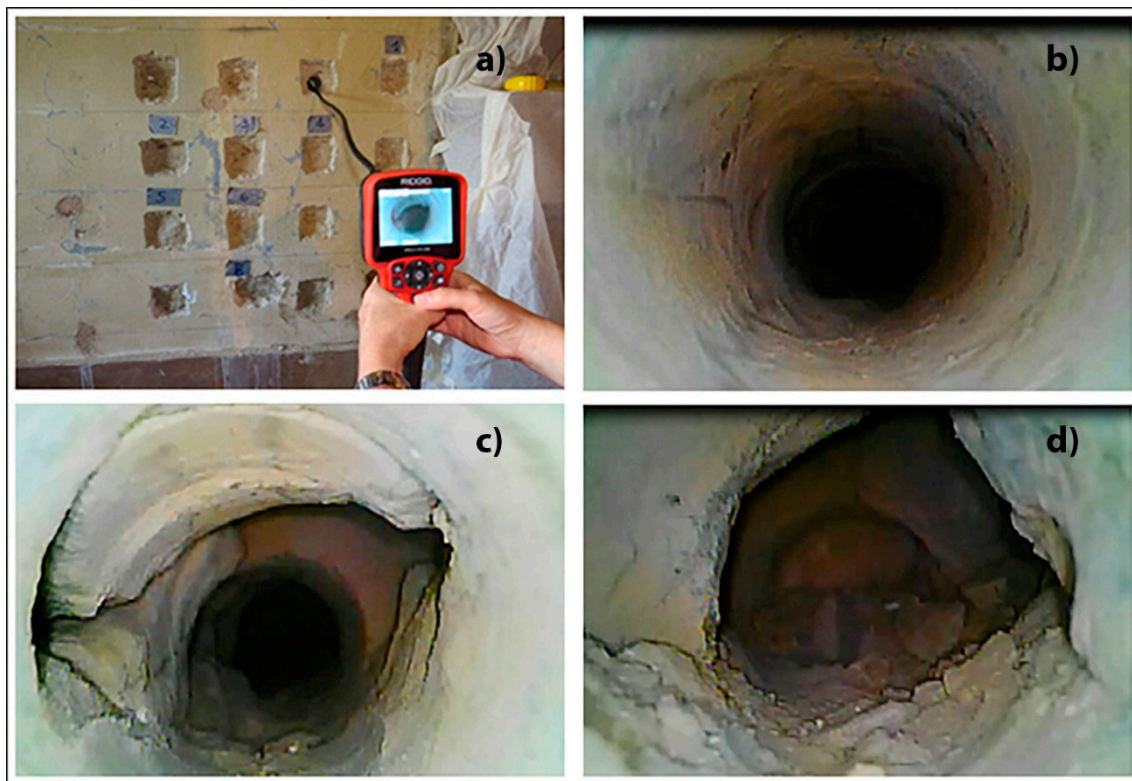
Figure 5. (a) Endoscopy surveys; (b) Initial section of compact masonry; (c) First discontinuity; (d) Central discontinuity between two walls.

The low sonic results also increased uncertainties about the presence of voids or cavities within the wall texture. Therefore, at one point of the sonic test mesh, a 48 cm long hole (half the thickness of the wall) was made for inserting the endoscope in order to visually investigate the masonry stratigraphy (Figure 5). In fact, the test shows, after an initial section of compact masonry, the presence of a first discontinuity. After the first layer of whole stone, the stratigraphy is characterized by the alternation of stones smaller than the first interspersed with discontinuities that are not entirely filled by the injections. Subsequently, there was a central discontinuity between two walls of equivalent thicknesses, the sum of which constitutes the thickness of the masonry. The acquired images also show the total absence of injections in the deeper layers of the masonry. The stratigraphy detected is the following:

- 0–15 cm: compact stone (Figure 5b);
- 15–22 cm: first discontinuity (Figure 5c)
- 22–48 cm: stones interspersed with discontinuity (Figure 5d).

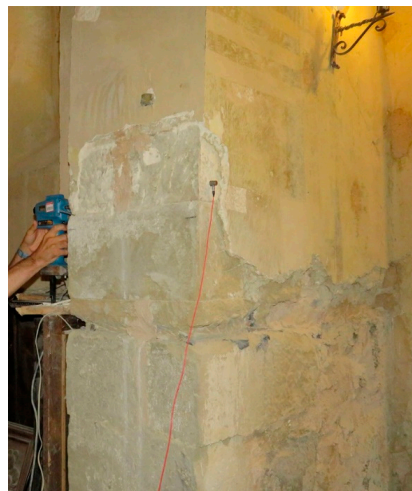
Figure 7. Impact test on single big sandstone constituting the masonry texture.

The analysis of the diagrams obtained from the tests on the single sandstone constituting the masonry texture (Figure 7) revealed a value of the elastic modulus equal to 15.978 MPa, in accordance with the values present in the scientific literature [21].

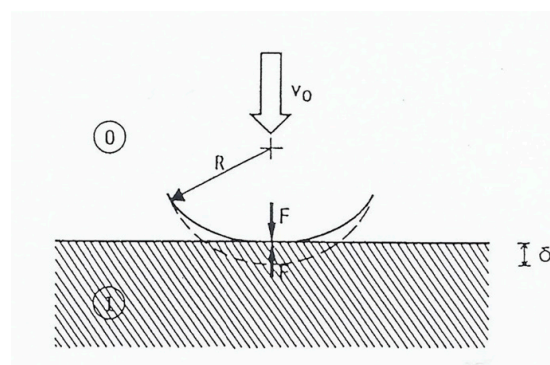
Figure A1. Movable mass in contact with the test surface.

The following considerations on the impact of a sphere on the flat surface of a semi-infinite space (Figure A1) derive from the classical theory of the elastic collision between two bodies in the absence of friction due to Hertz [20]:
